Maryland Historical Trust State Historic Sites Inventory Form

1. Nam	e (indicate pr	eferred name)		
historic				
and/or common	Frank Fairbanks	: House		
2. Loca	ation			
street & number	Fairbank Road		_	_ not for publication
city, town	Fairbank	vicinity of	congressional district F	ifth
state	MD	county	Talbot

Survey No. 7-827

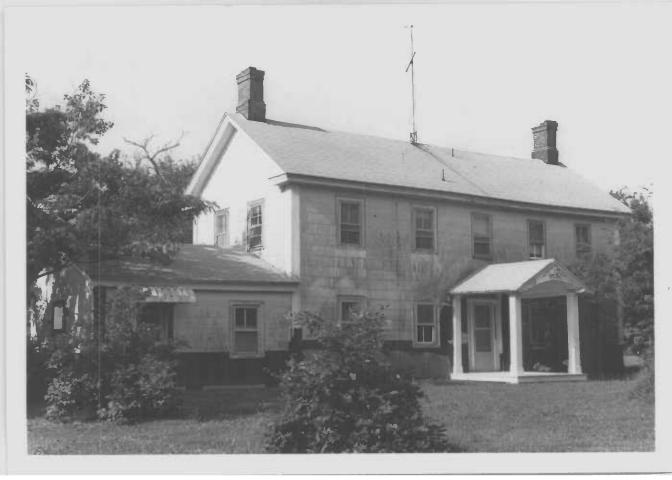
MORTHWEST ELEVATION

The north (main) facade has a central door flanked by a pair of two-over-two sash windows. The windows on the eastern bays have wide surrounds, while the windows on the western bays have narrow surrounds and are inset at a lower point in the wall. A gable roofed portico shelters the door. While the supports for this portico are new, the roof and tongue in groove platform are original. The second story has five two-over-two sash windows. The three western bay windows have narrow surrounds, while the two eastern bays have wide surrounds. The house has cornerboards and a boxed cornice.

The two bay west elevation has two-over-two sash windows on the first and second floors with narrow surrounds. A centrally placed interior chimney rises above this west gable.
